# Bird Barrier<sup>®</sup> Optical Gel<sup>™</sup>

## CASE STUDY » Pub

## CASE STUDY » Hotel

## CASE STUDY » Shopping Center

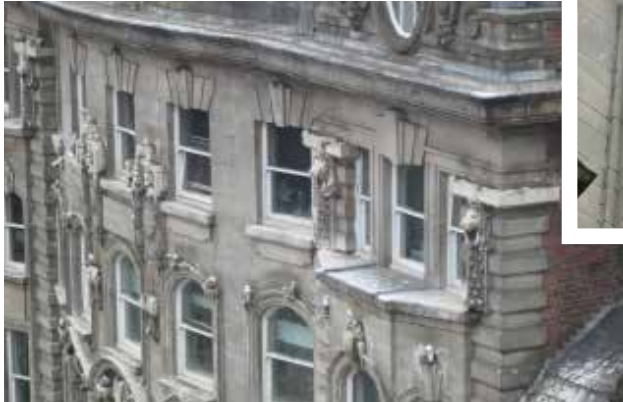
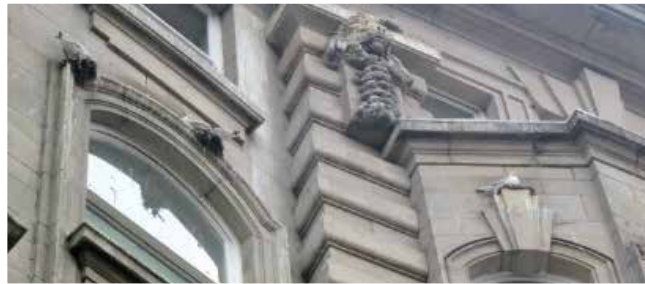
*The large number of gulls present during the summer months (more than 30 gull nests were observed on the lintels, cornices and other architectural features) was resulting in extensive fouling of the façade and the pavement below.*

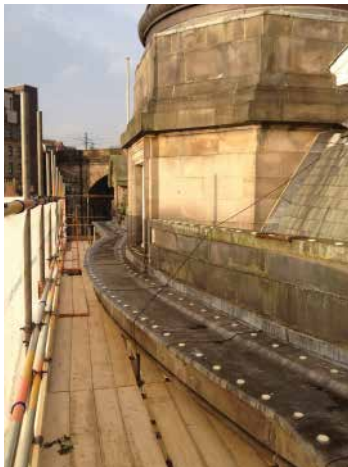
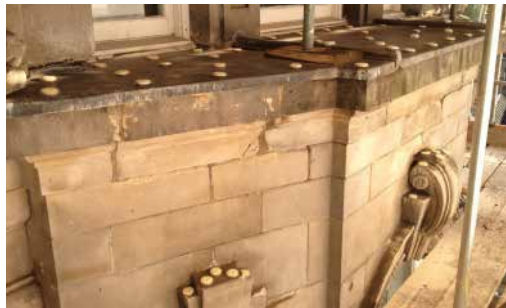
The entire façade was pressure-washed and all nests were removed. To prevent day roosting, the cornice above the fourth floor was treated with two rows of dishes of Optical Gel at 12 in. centers (left); while the deep ledges in front of the three bay windows on either side of the façade at the fourth floor were treated with three rows of dishes at 12 in. centers.

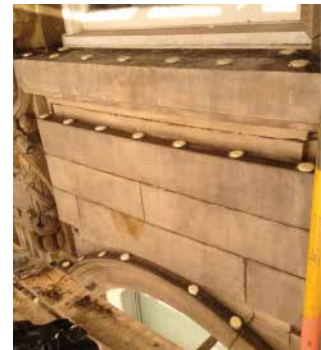
At the third floor, nests were removed from the curved lintels above the central windows. Optical Gel dishes were placed at 6 in. centers

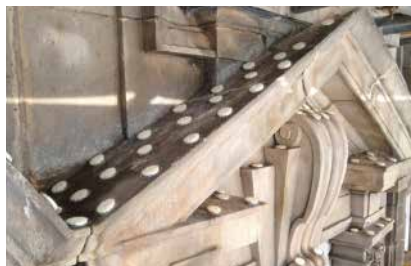
At the second floor, all nests were removed from below the curved lintel above the central window, from below the inverted V-shaped lintels on either side and from the architectural features to left and right. All these surfaces were treated with dishes of Optical Gel at 6 in centers to prevent nesting.

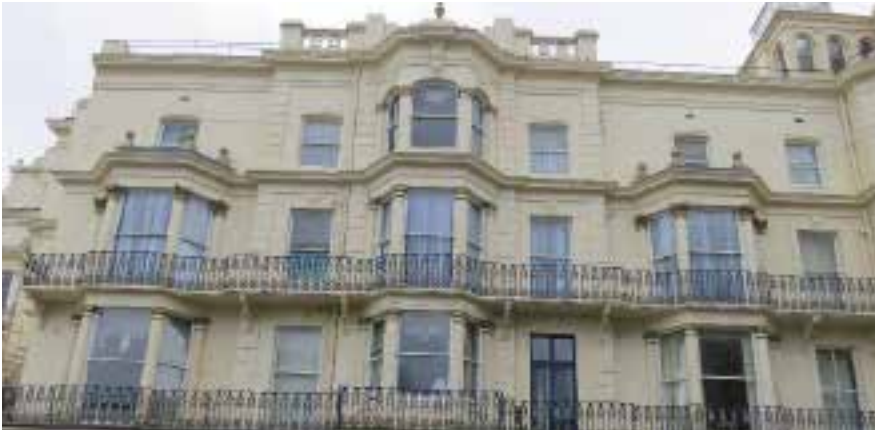
*Gulls had been nesting on this hotel for many years during the spring and summer months. Their presence resulted in noise and unpleasant odors that discouraged guests from using the terrace with ocean view at the front of the hotel.*

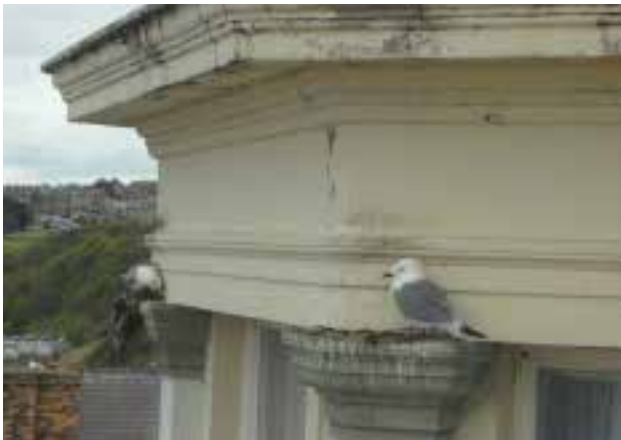
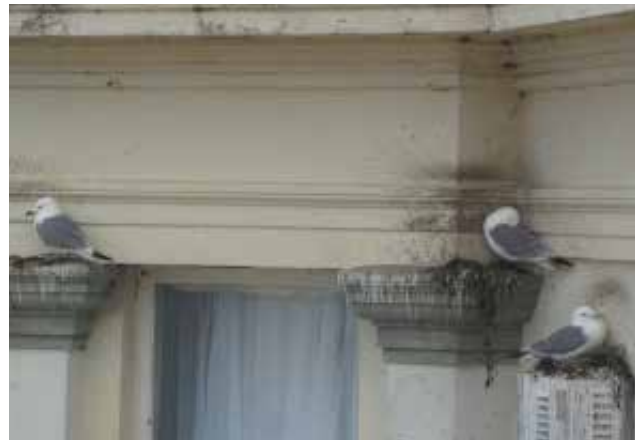
Optical Gel dishes applied to the façade above the main entrance are invisible from below

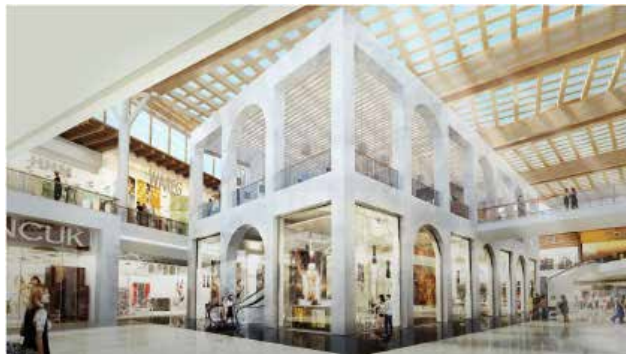
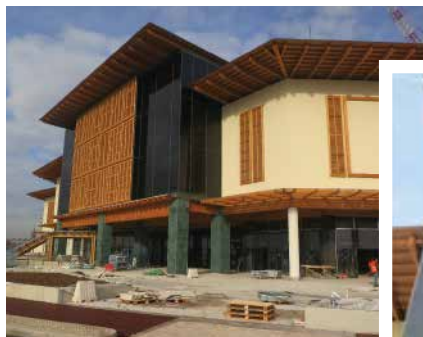
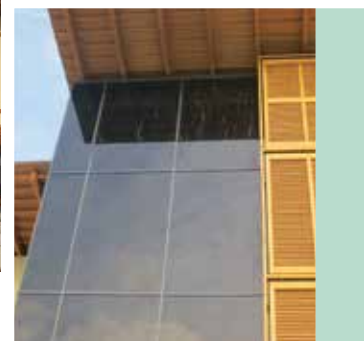
Even before construction was completed pigeons started to roost in sheltered parts of the building. Pigeons roosting below the roof were creating an unsightly mess on the glass façades

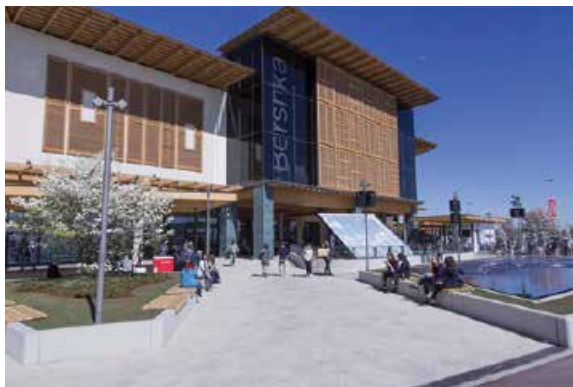
The owners of the shopping center decided that prevention was better than cure. So, in December 2015 approximately 9,000 dishes of Optical Gel were fixed to all the sheltered parts of the structure. (The covers were subsequently removed from the dishes.)
